ENGINEERING TEST REPORT

ETR - 924

TITLE: Test Results of the RAH-66 Main Rotor Ballistically Damaged Flexbeam
DATE: 4 August 1997
A/C SERIES: RAH-66
A/C MODEL: RAH-66 Prototype
SYSTEM: Main Rotor
CHARGE NO: CB571-300
CONTRACT NO: DAAJ02-97-M-0001

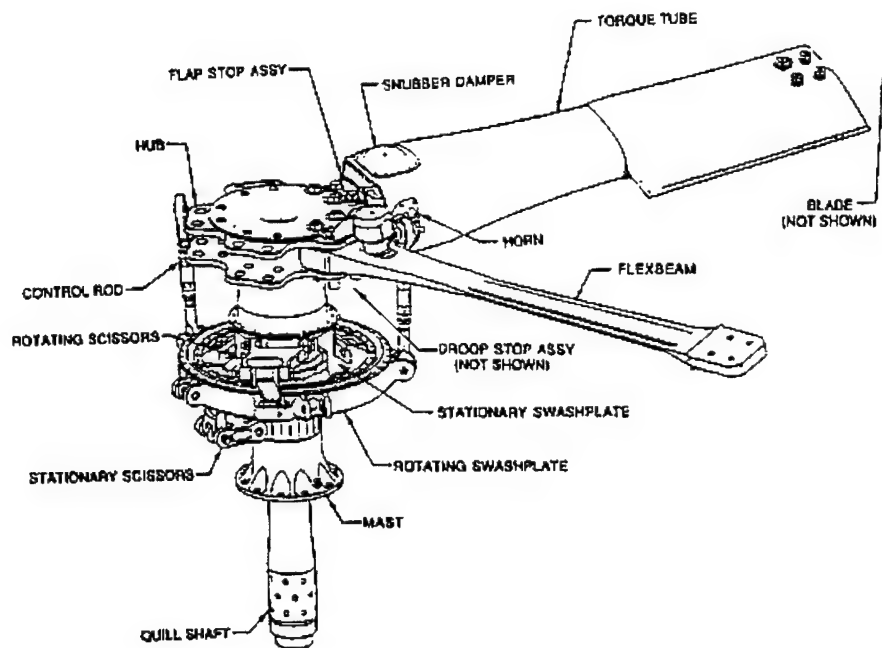
Figure 1 RAH-66 COMANCHE Main Rotor System

The COMANCHE main rotor system is a five-bladed, bearingless design, Ref. Figure 1 thru 3. In this design each of the blades is retained by a flexible composite beam (flexbeam). The flexbeams attach to the main rotor hub plates and to the inboard ends of the five blades. The flexbeams accommodate the flapping, lead/lag, and pitch change motions of the blades through elastic bending and twisting.

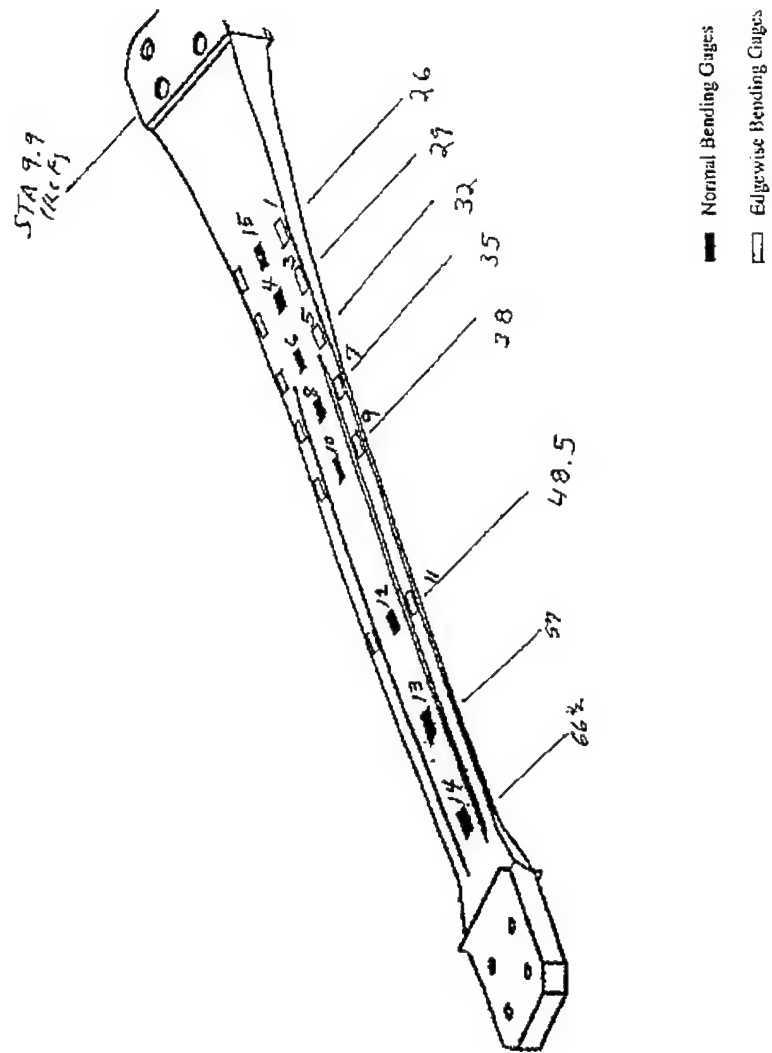
Figure 4 Ballistically Damaged Flexbeam S/N 0044 Instrumentation

The S/N 0044 flexbeam was instrumented at AATD with the bending bridges shown in Figure 4. Since the ballistic damage made the centerline flatwise bending bridges inoperative, secondary flatwise bending bridges were installed slightly offset chordwise.

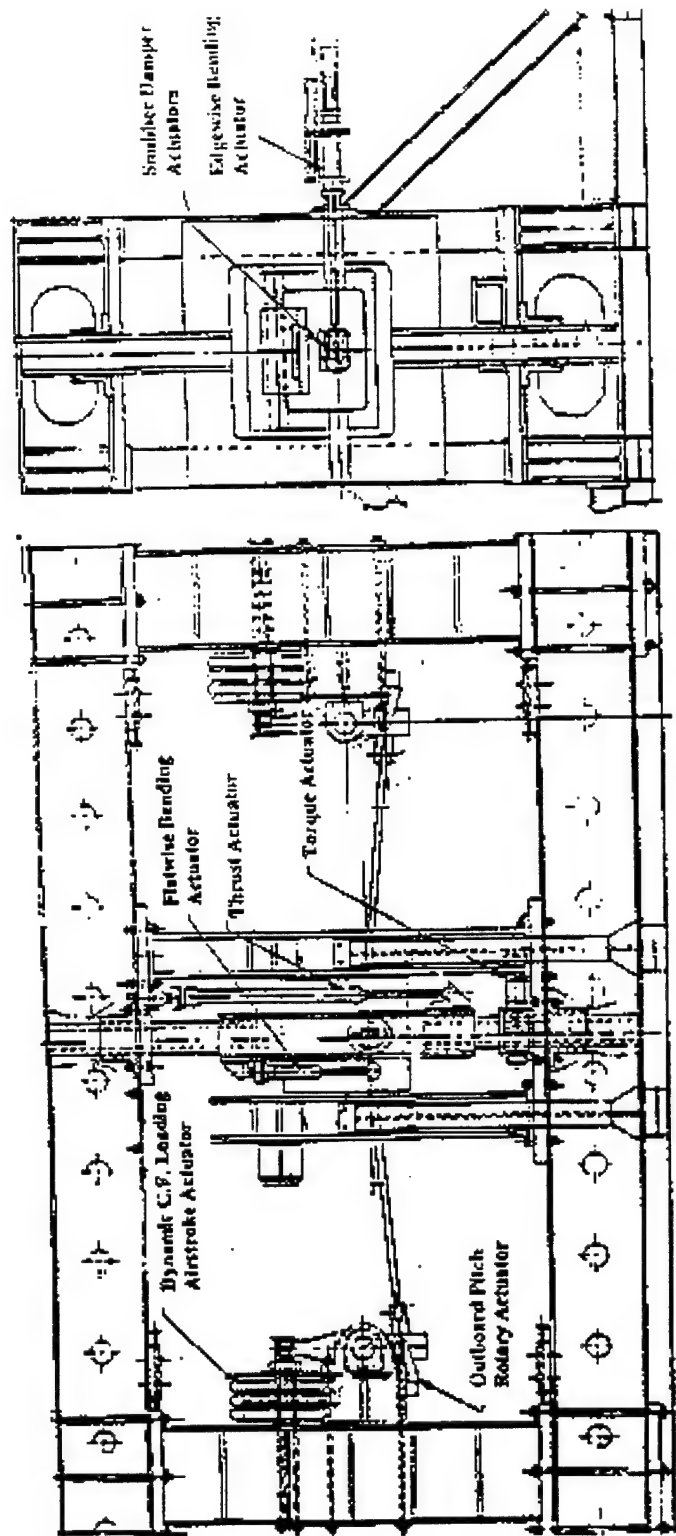
Figure 10 Sketch of Test Facility

The ballistically damaged RAH-66 Comanche flexbeam was fatigue tested in the Reference 2.2.1 test facility, Figure 9 & 10. This facility is designed to test two specimens simultaneously. The second specimen, S/N 0001, is not considered a test specimen and was mounted in the facility to allow testing of the ballistic flexbeam, S/N 0044. The flexbeam specimens were mounted in a facility hub 180 degrees apart as shown in Figure 9. The facility hub is representative of the aircraft hub in the flexbeam attachment area. A dummy quill shaft flange was included in the hub assembly to assure proper loading of the inboard flexbeam attachment bolts. The outboard ends of the flexbeams were attached to facility spindles which provided centrifugal force through the use of a pneumatic bellows arrangement, and torsional pitching moment through the use of an electrically controlled hydraulic rotary actuator. The facility provided flatwise shear by raising the center carriage vertically. Flatwise moment was produced by rocking the center carriage about the flapwise axis. The edgewise moment was produced by translating the center carriage horizontally. Both the flatwise and edgewise motions were imparted to the flexbeams through the use of electronically controlled hydraulic actuators. An electronic cycle counter monitored the number of test cycles applied to the specimens. Snubber/damper preload was simulated through a mechanical clamping assembly, and the vibratory damper chordwise shear loads were simulated through an electronically controlled hydraulic actuator.
